Creating a Grease-Free Environment At Dinorwig Power Station

By William O. Moss

The 1,728-MW Dinorwig Pumped-Storage Power Station in the United Kingdom undergoes many modes changes per day in providing system stability and reserve for the national grid in England and Wales. In doing so, its greased bronze turbine bearings sustain severe wear. After conducting extensive tests, operator First Hydro decided to install grease-free bearings, with the help of an innovative in-situ milling machine.

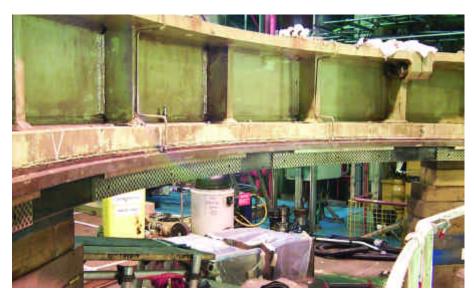
This photograph shows a new self-lubricating Lubron AQ30 regulating ring bearing in place at the Dinorwig power station in the United Kingdom, the last step in First Hydro Company's goal to create a completely grease-free turbine.

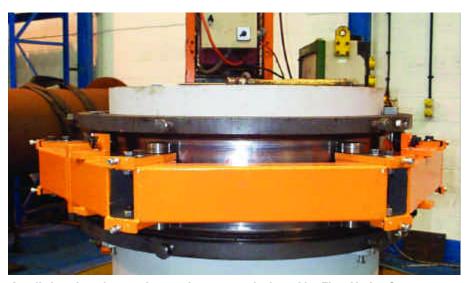
A split-bearing sleeve, shown above, was designed by First Hydro Company and contractor Furmanite to help guide a milling machine as it rotated around the main turbine shafts during a bearing replacement project at the 1,728-MW Dinorwig Pumped-Storage Power Station.

Extensive development work followed. First Hydro supplied the requirements, while Furmanite adapted the machine to the application. The main adaptation was to assemble and rotate the machine around the turbine's main shaft. For this, a special split-bearing sleeve was designed, along with a clocking arm for setting the sleeve up concentrically with the bearing track. Of major importance was the flatness of the bearing track, but this was easily achieved with the milling machine's self-leveling technology and a specially designed split datum ring. The datum ring was pre-set using Furmanite's precision scanning laser system to give very high accuracy.

lubricating segmented bearing. Furmanite machined the bearing track (horizontal and vertical) using the specially developed milling machine, removing approximately 3 millimeters of material before fitting the stainless steel liner segments.
